Report No: F1RSOQ76EI

Roof Inspection Report

Inspection Date : 11 May 2022

Property Address : 1 Philps St, Sydney

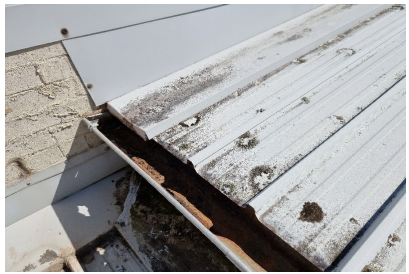
Item	Condition	Description	Photo(s)
Roof gutters condition:	Poor	aged gutter, repair required

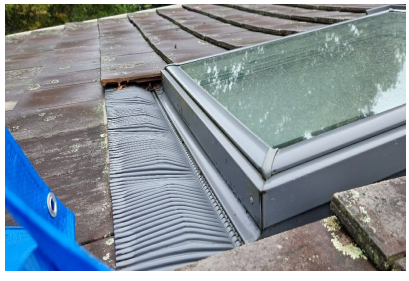
Rooflights/Skylights:	Poor	lower flashing not sitting flush

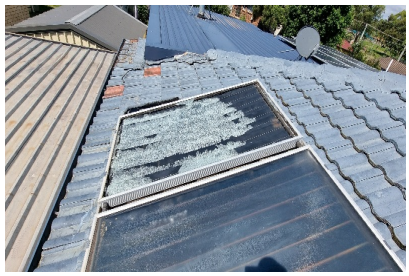
Solar panel condition:	Poor	required maintenance

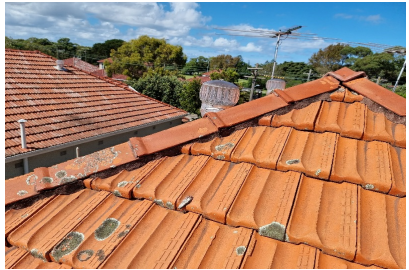
Ridge and hip ridge condition:	Poor	beddings required repair
